GRAMPAW PETTIBONE

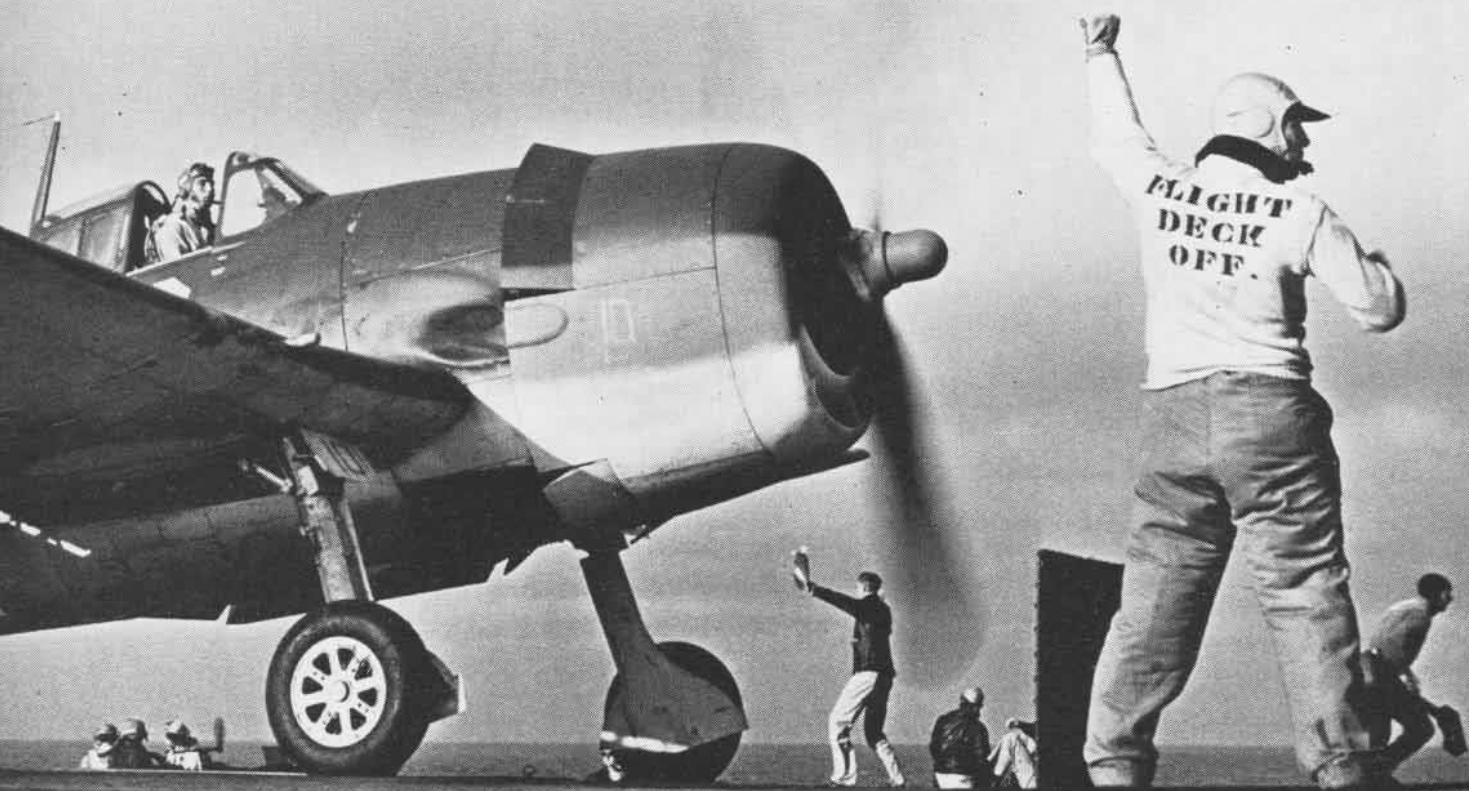
Navy "Hellcat" is poised awaiting take-off signal from the Fly One officer who is intent on seeing that preceding plane clears the deck. Landing signal officer in background directs the approach of another plane. This is typical of the split second timing aboard a U. S. escort carrier
